# Improving waste landfilling practices in Africa: the case of Maputo

**Keywords:** semi-aerobic waste landfill, dumpsite improvement, municipal solid waste

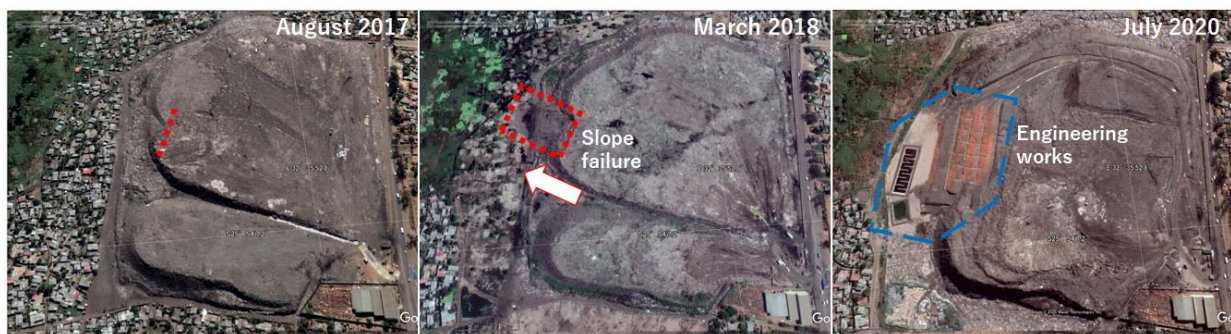
**Figure - Landfill before (left) and 1 month after slope failure (center), and after rehabilitation (right)**

Engineering and the Fukuoka Method related works lasted from November 2019 to July 2020 and consisted of 150 m of slope correction using terraces to guarantee slope angle of 1:3, installation of gas venting pipes, installation of leachate collection system and a simplified leachate treatment/evaporation pond. Operation practices included knowledge transfer on appropriate waste disposal using work faces and waste cells, maintenance of access roads, and adaptation of elements of the Fukuoka Method using low-cost material and or waste found in the site. The interventions and knowledge transfer resulted in improved security in the collapsed area and now serve as a basis for expansion of improvements across the whole landfill.
